BONTEX / BUENA VISTA PAPER COMPANY

Building Complex Reuse Study

Buena Vista, VA

CONDITIONS ASSESSMENT

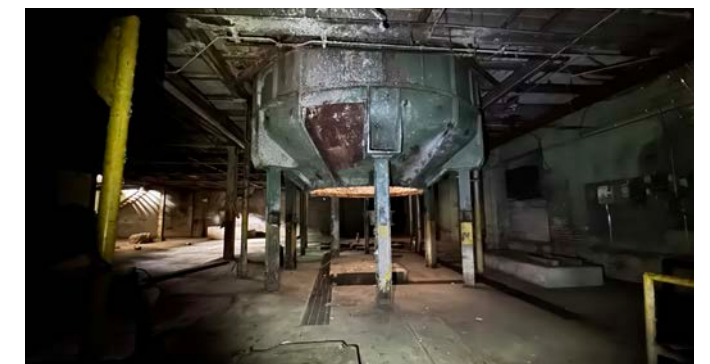
Tank in Section L.

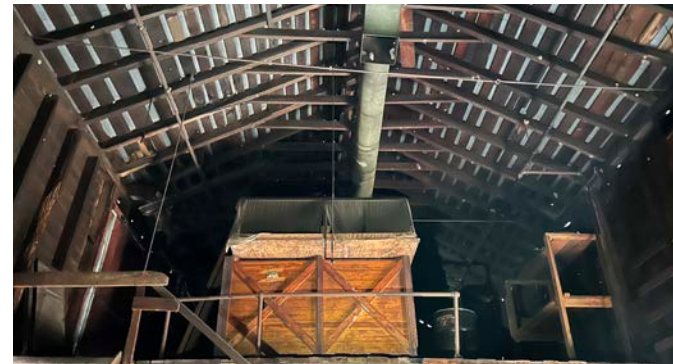
Chip House interior.

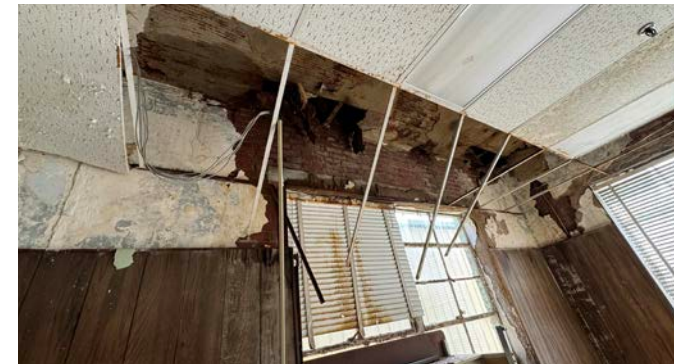
Water infiltration and damage in Section D.

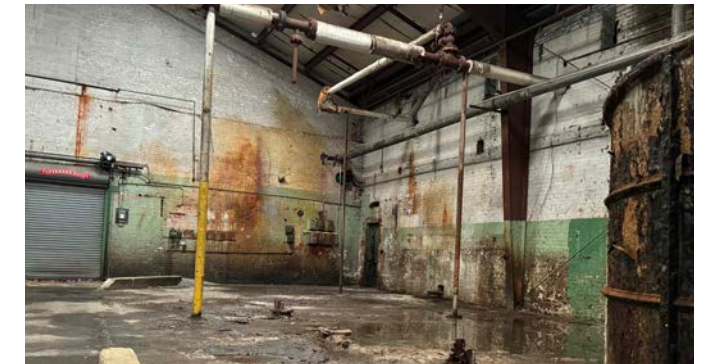
Standing water in Section I.

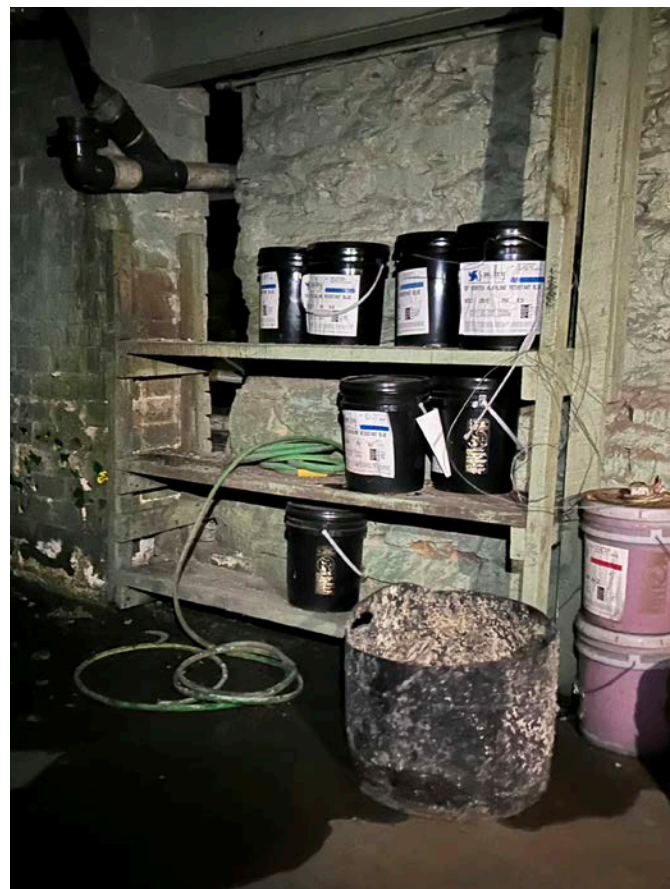
Basement chemical storage area.

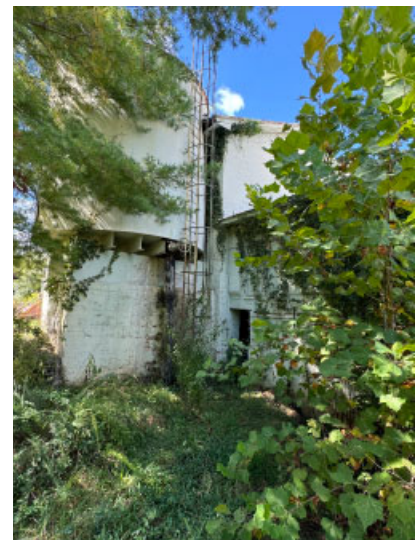
Section B: Exterior wall integrated tank.

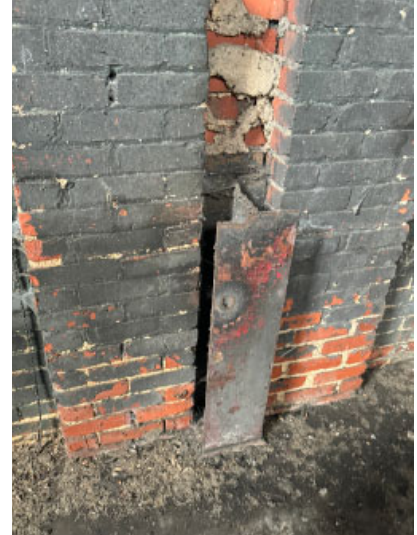
Section G: Cut off steel column.

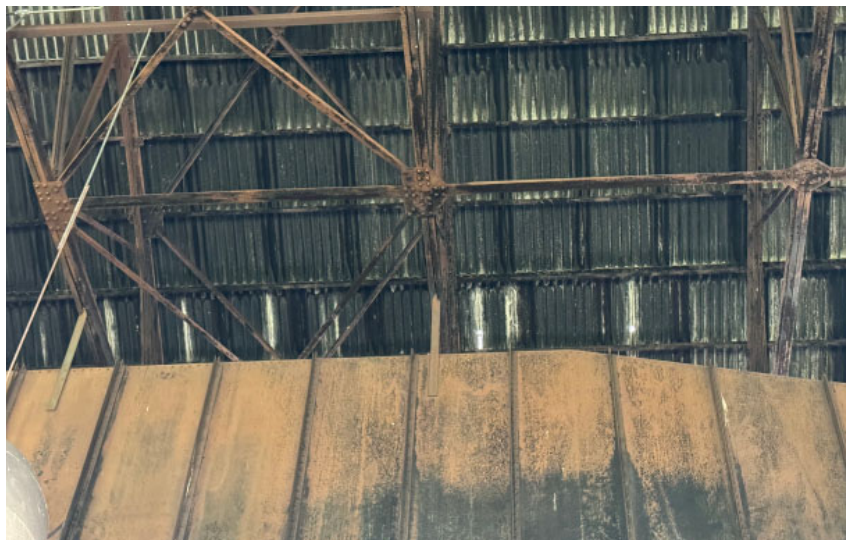
Section G: Roof and framing condition.

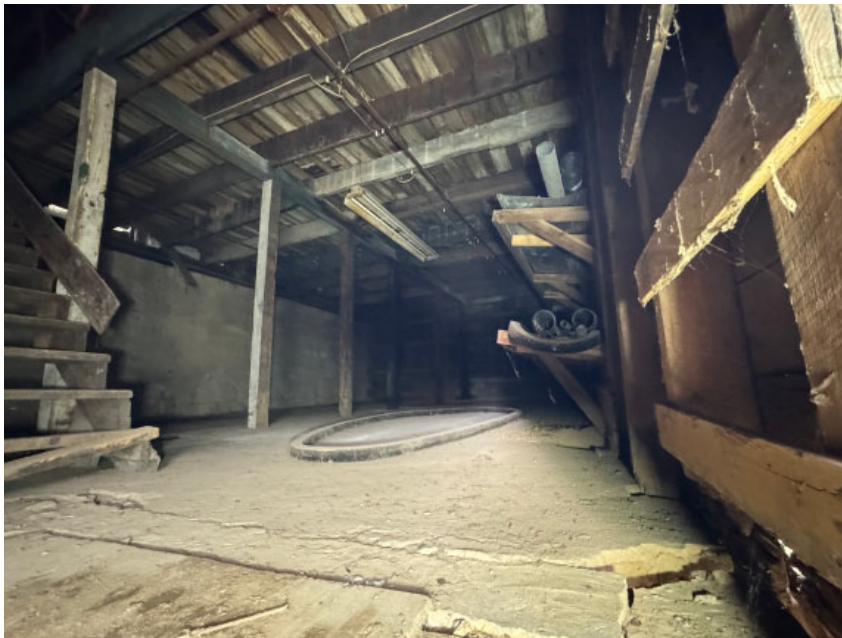
Building X: Interior structure condition.

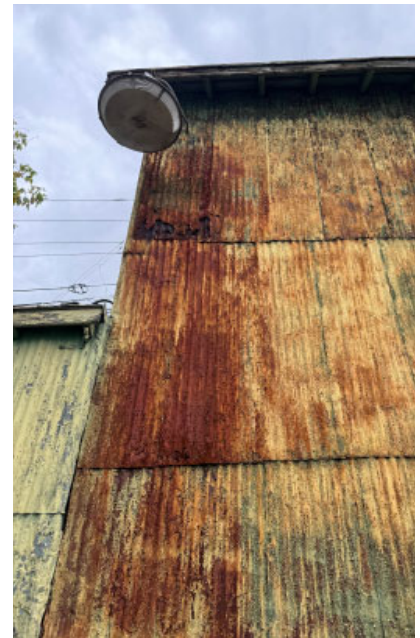
Building X: Exterior condition.

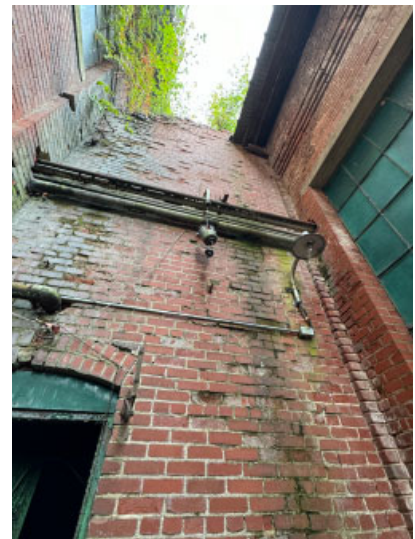
Section I, between Section G (left) and Section E/F (right): Masonry deterioration.

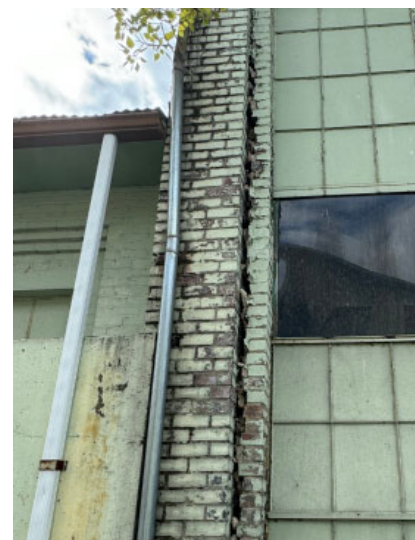
Section B: Pilaster failure on north wall.

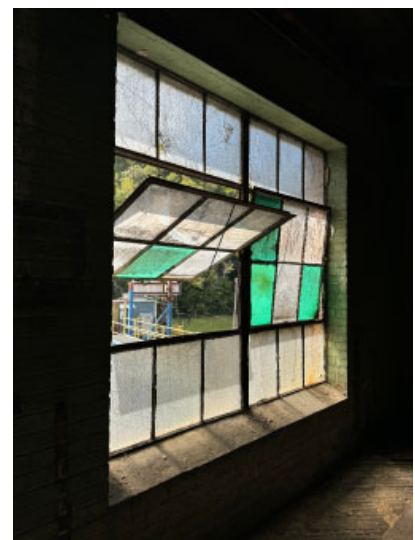
Section I, second floor: Typical window.

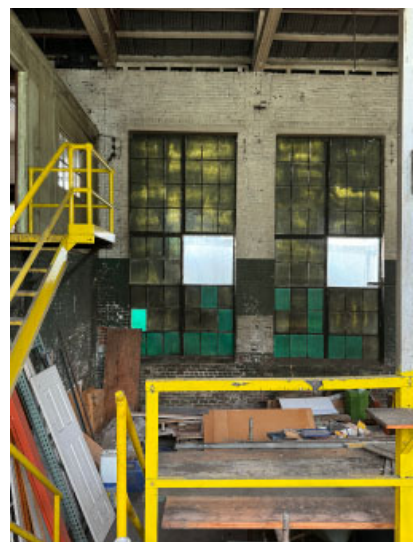
Section B: North windows.

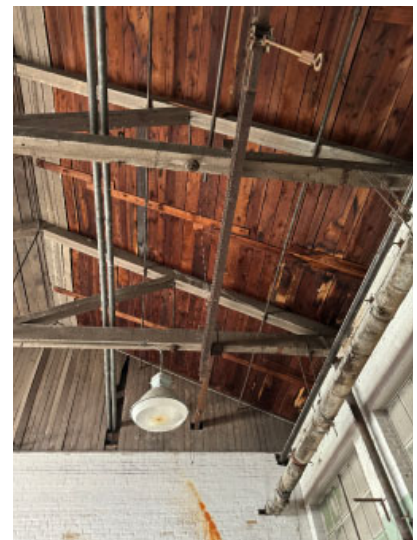
Section B: Room 4 replaced wood decking.

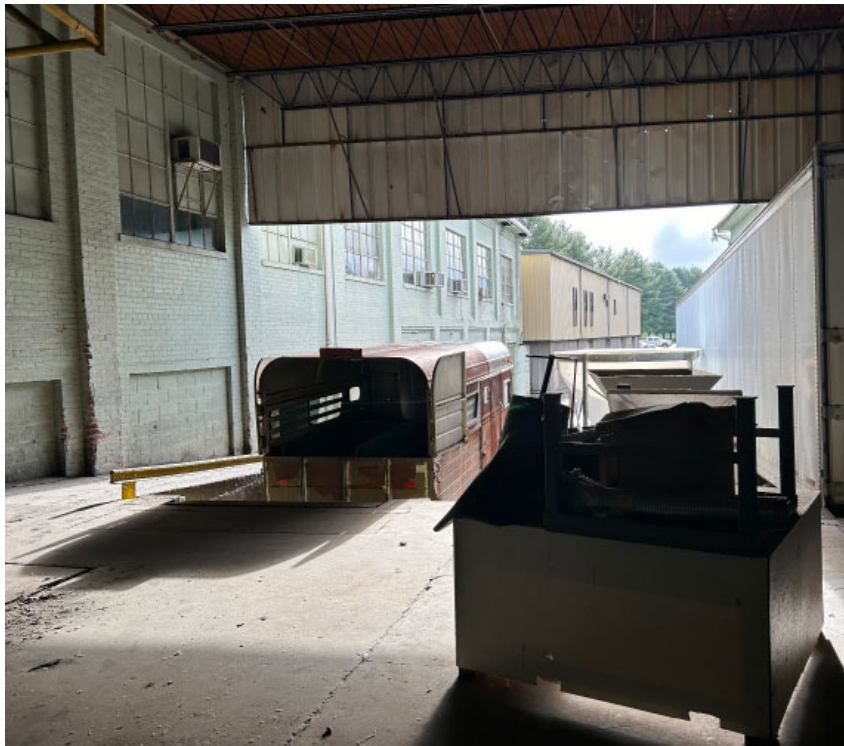
Section C: Platform lift that accesses Section D.

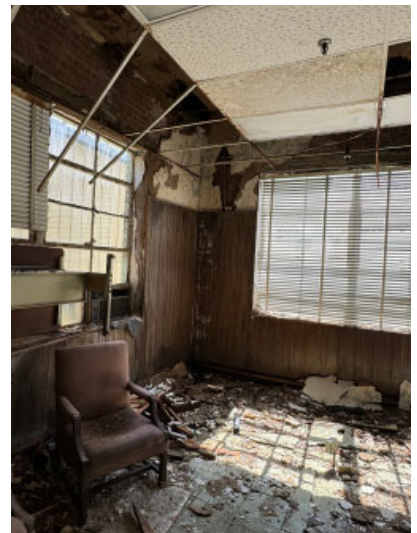
Section D: Southeast corner office condition.

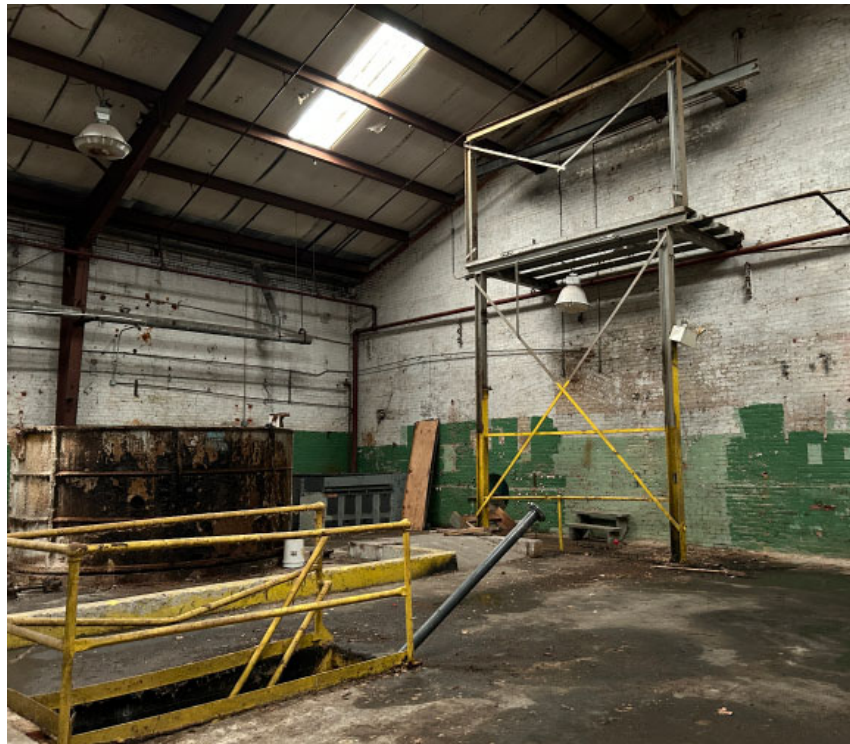
Section I: Northeast corner.

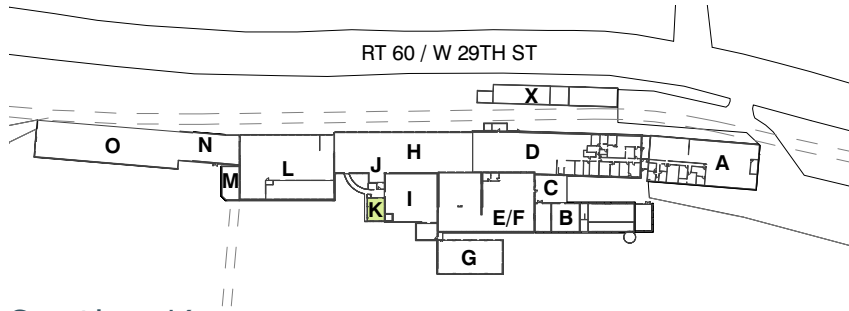
Section K: Northwest corner and wood catwalk.

Section K has a sliding door on the north side, and a swing door at the southern end of the west wall, both connected by a catwalk constructed of metal framing and wood decking. The catwalk is severely deteriorated and its condition prevented access to Section K.

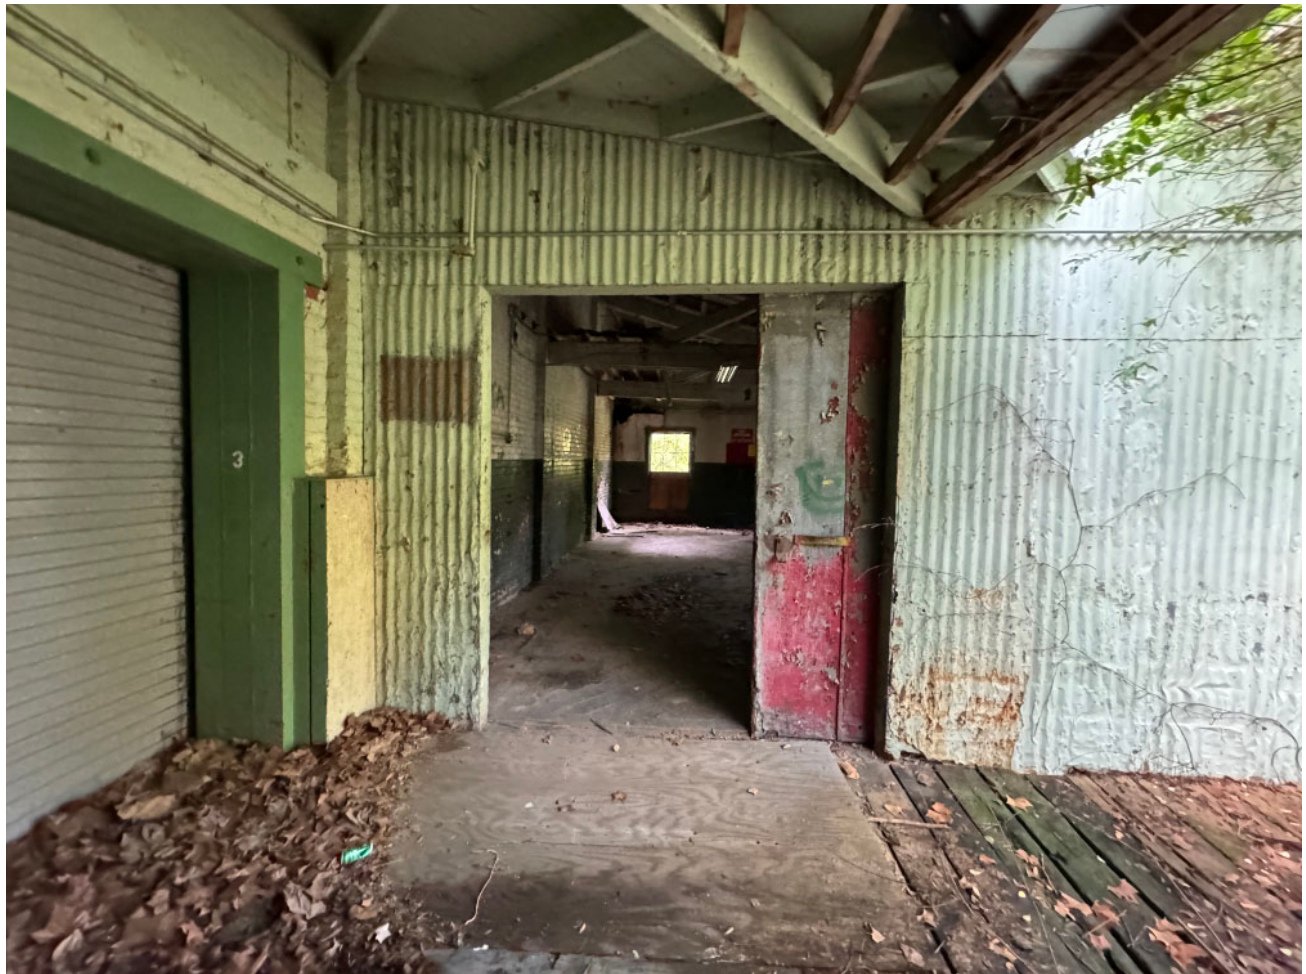
Section K: North wall and partial interior view.

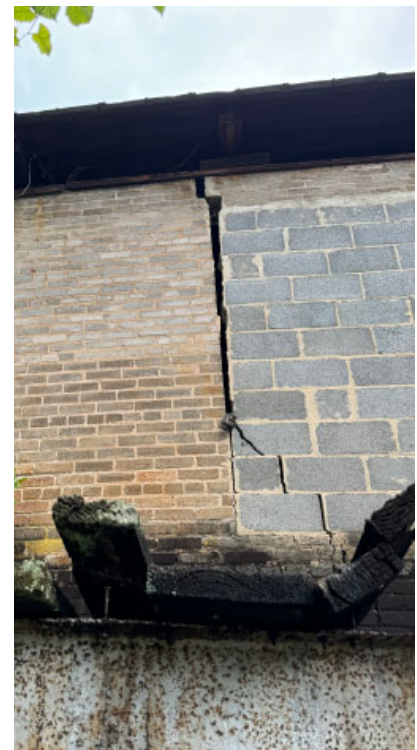
- Stabilize the structure of Section M and the Chip House (Building X). Section M has severe failure of masonry elements, and the Chip House has extensive termite damage affecting its structure.

Section M: Failed brick masonry arch.

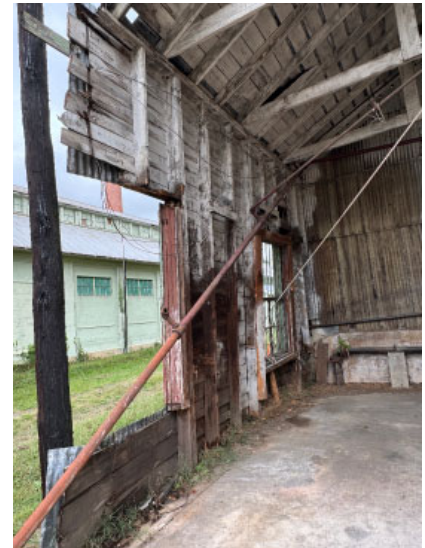
Building X: East end deterioration.

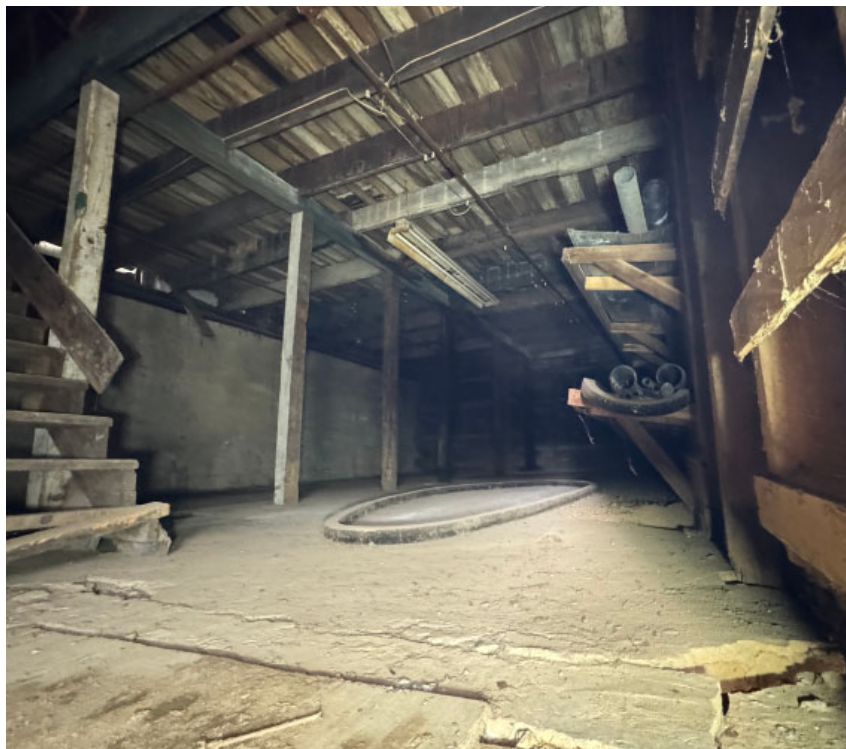
Building X: Interior condition.

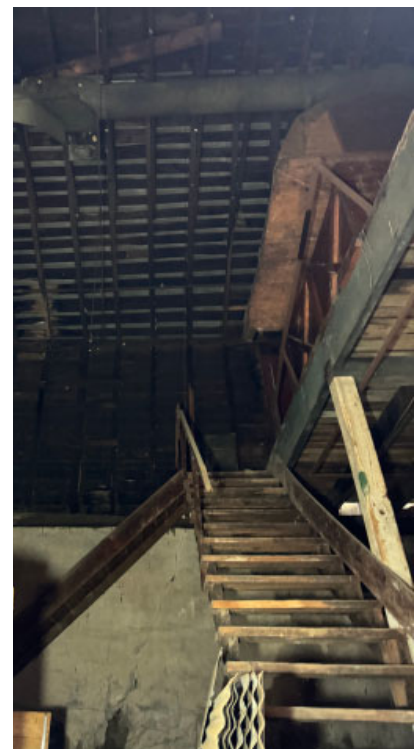
Building X: Access to mezzanine level, wood roof framing above.

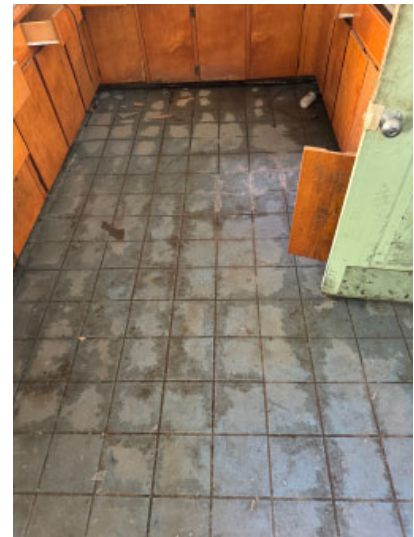
Section D Laboratory: Flooring.

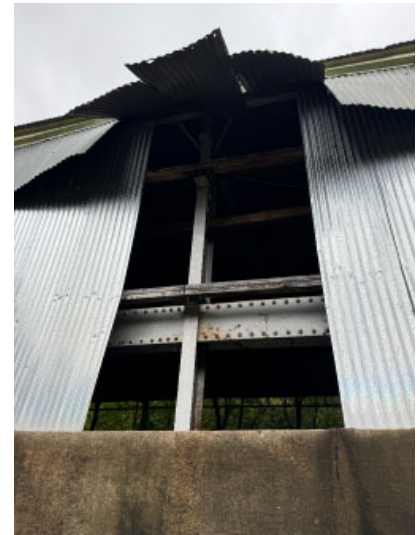
Section N: Metal wall panel condition.

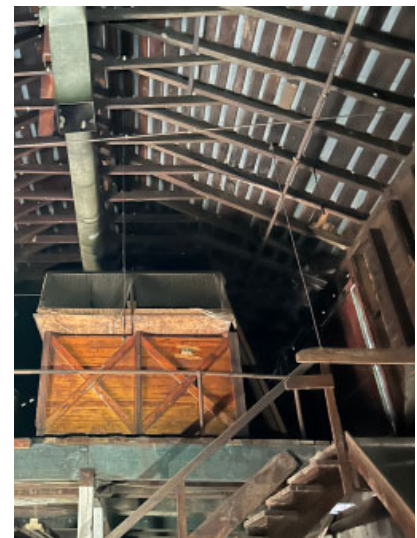
Building X: Interior.

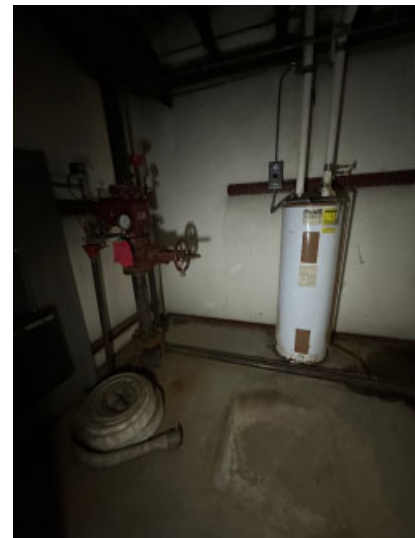
Section A: Basement water heater and sprinkler valves.

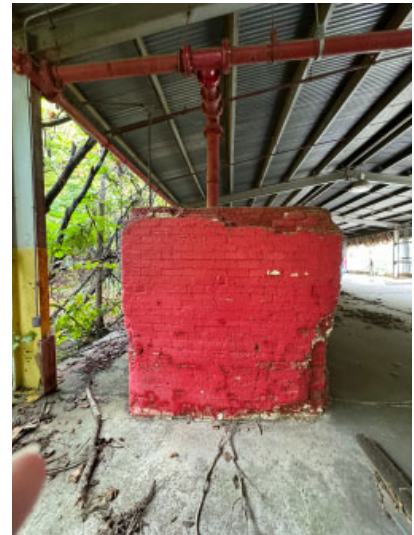
Section O: Sprinkler valve enclosure.

- Design and install a new sprinkler system if required by the building code based on future use, occupancy, and design of the space.
