# Buena Vista, Virginia

## Stormwater Risk & Resilience Plan of Internal Streams

June, 2026

**Civil Consulting  
Group, P.C.**  
ENGINEERING  
DESIGN & ANALYSIS

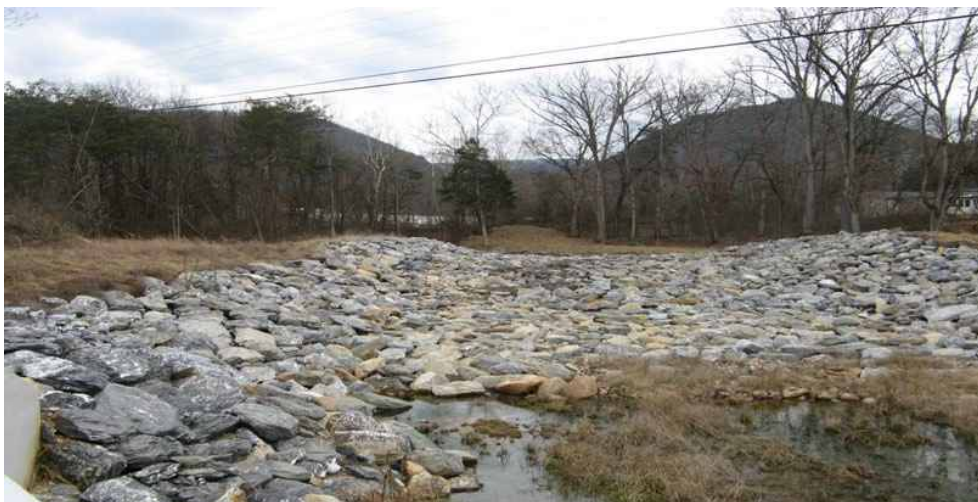
*Debris Basin on Chalkmine Run shortly after construction*

NRCS recommended constructing seven additional debris basins on three interior streams. The City should examine ownership of the recommended locations and explore costs associated with acquiring properties and constructing the debris basins. Based upon limited cost data from the NRCS report, the total cost of an average basin in 2025 is estimated at \$651,000 for a total cost of \$4.56 million. Buena Vista should rank potential locations based upon usefulness and cost, then pursue funding to acquire the land, then design and construct as many basins as possible.

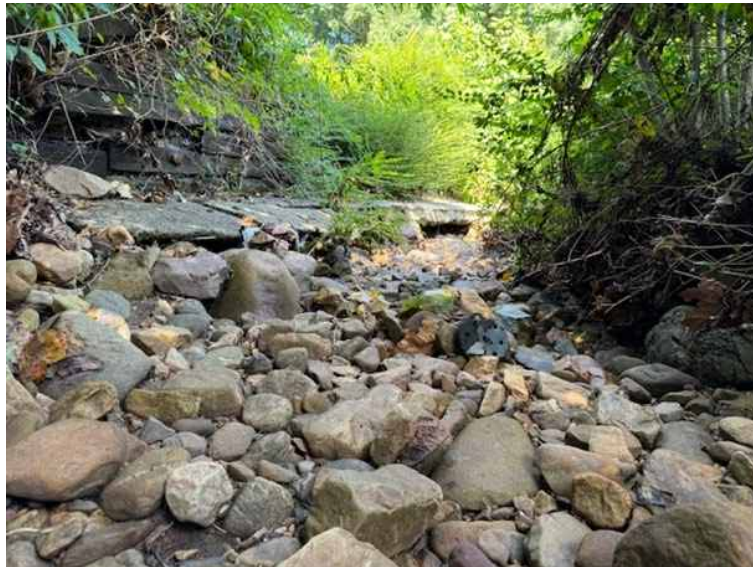
*Wooden Crib Wall at Left, High Flow Concrete Overbank, and Low Flow Natural Channel with Cobbles*

Elements of other projects are visible along the streams in Buena Vista, but their timing and impetus for creation are often unknown. For instance, in the mid-1970s, Pedlar Gap Run was reinforced on one side with a gabion basket wall at Woodland Avenue and a corrugated metal culvert was constructed at the crossing. Upstream of the gabion wall is an older wooden crib wall of unknown vintage. In 2023, the corrugated metal arch culvert at Woodland Avenue began collapsing at its inlet and separating from its headwall. In 2025, a temporary repair was made to reinstate the entrance. The culvert has extensive corrosion and recommended for near-term replacement later in this report.

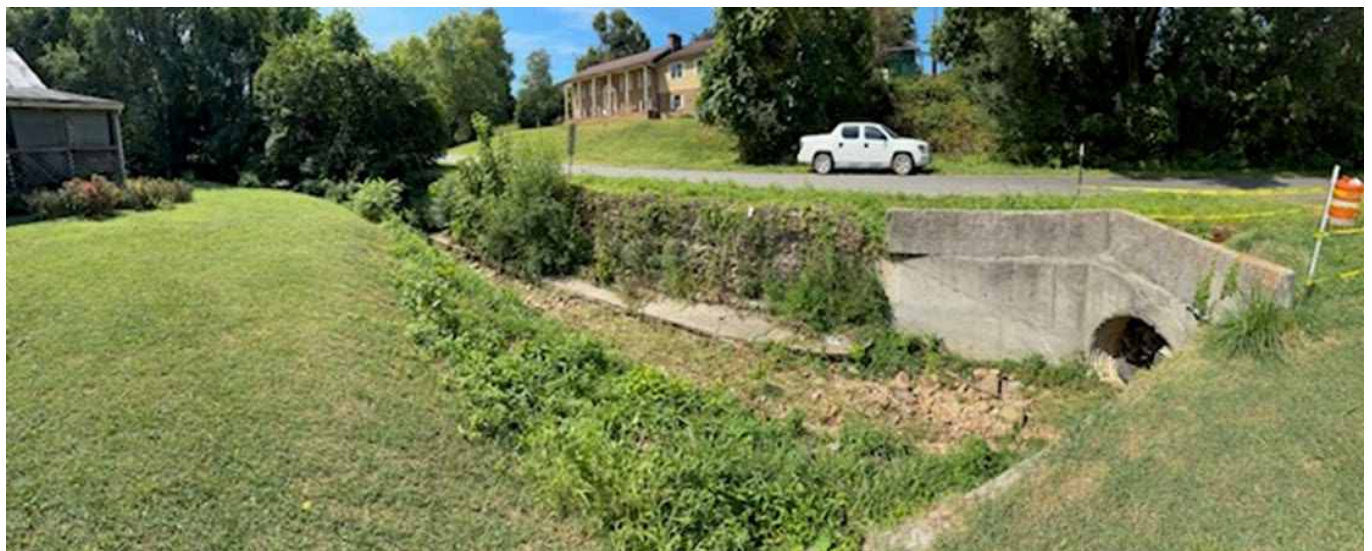
*Vegetated Gabion Wall at Woodland Ave Culvert (Constructed Circa 1977)*

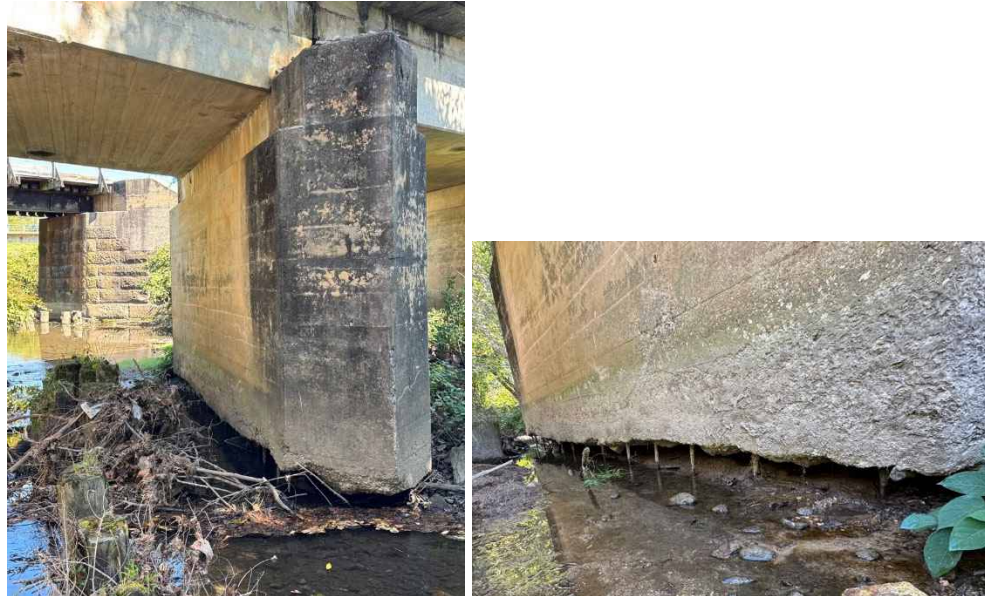
*Scour Under Pier of Upstream Railroad Bridge (set for repair)*

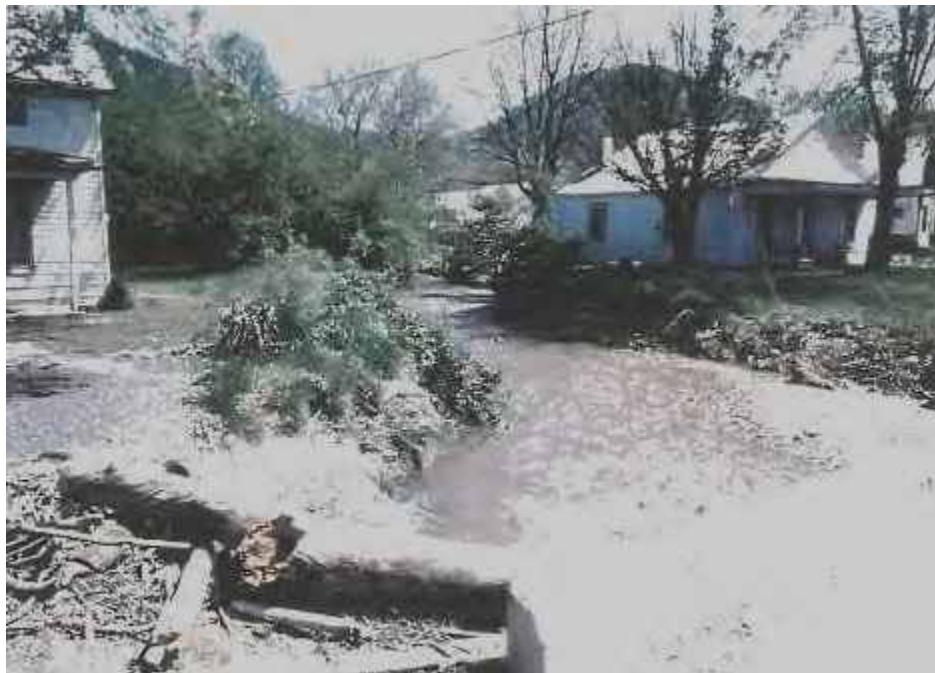
*Debris and Sediment Blocking Street Culvert Opening (bottom left)  
Near Confluence of Noel's and Indian Gap Runs after April 1992 Flood*

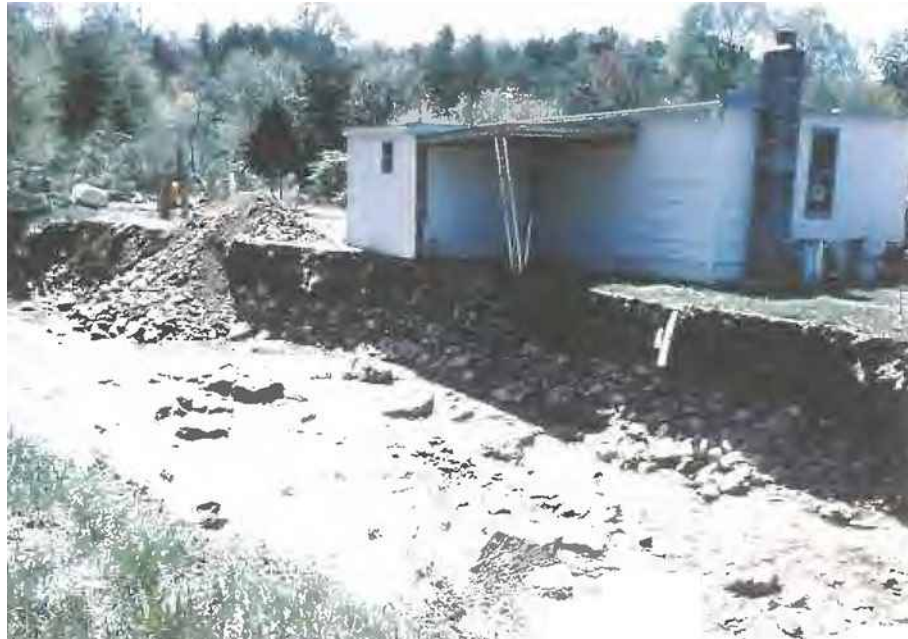
Scouring of Stream Channel on Pedlar Gap Run after April 1992 flooding

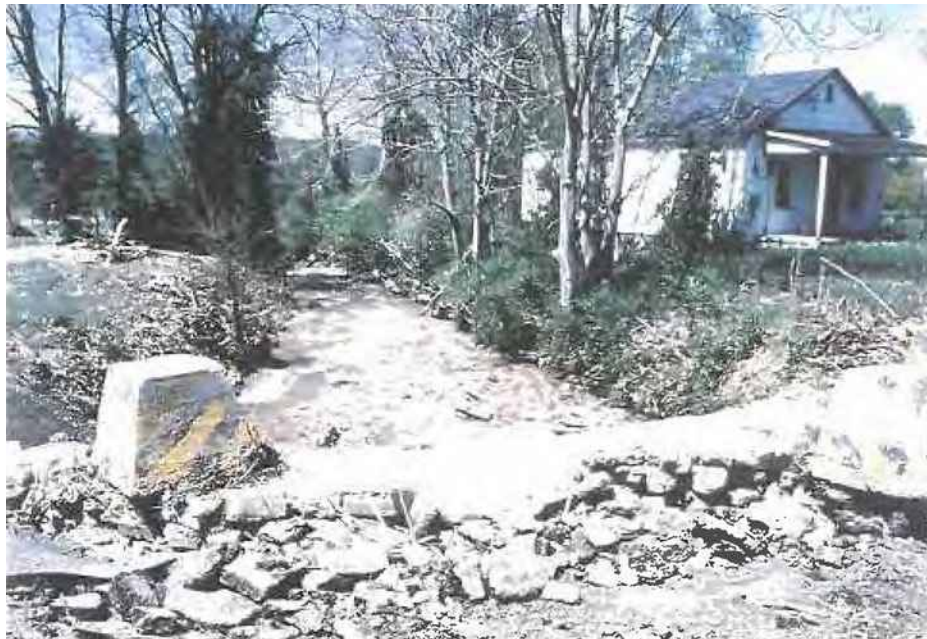
Destruction of Street and Blockage of Culvert with Debris and Sediment on Pedlar Gap Run from April 1992 Flood

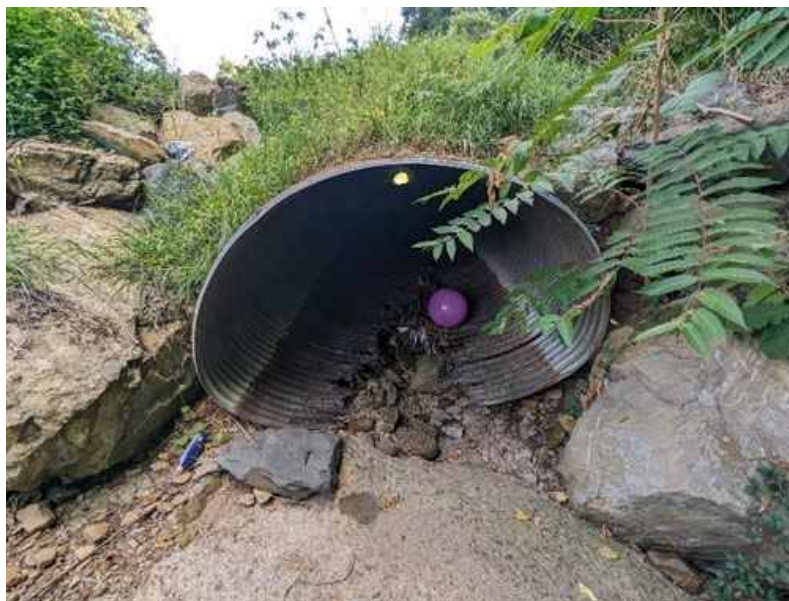
Outlet Showing Complete Absence of Pipe Bottom for Entire Length

We recommend that the City prepare a Preliminary Engineering Report (PER) to model the floodplain through this area to determine the logical size for the replacement structure. It would examine numerous iterations of channel size and upstream/downstream improvements, then recommend a replacement size based upon all factors. For instance, it may prove unworkable to construct a Hyspan or culvert that is wide enough to pass the 100-year storm event without substantially widening the channel and affecting adjacent houses. In other words, it could become a prohibitively expensive slippery slope. It may prove more appropriate to pass a smaller event such as the 25-year storm. The City should apply for a CFPF grant to fund the design and construction of the replacement structure.

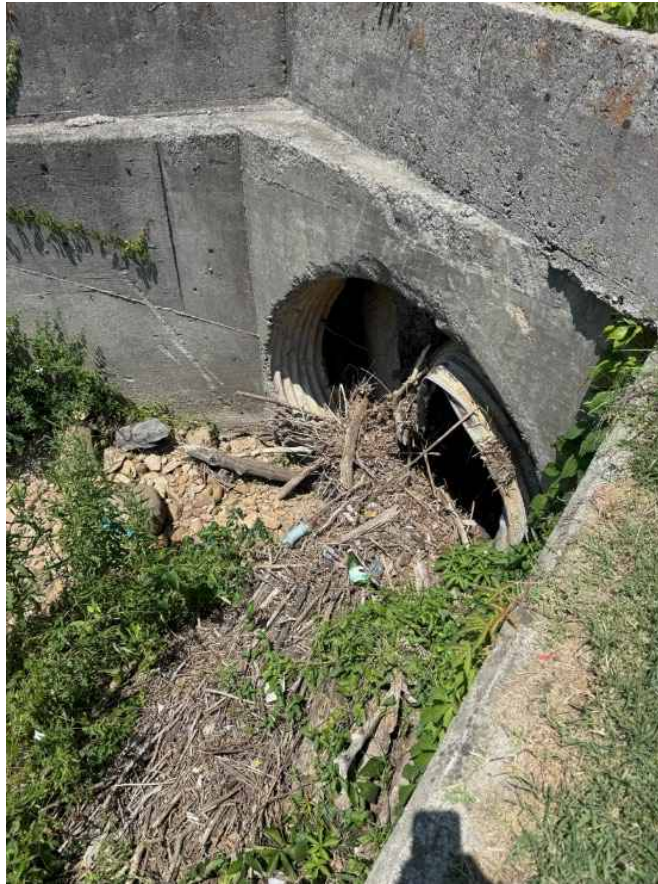
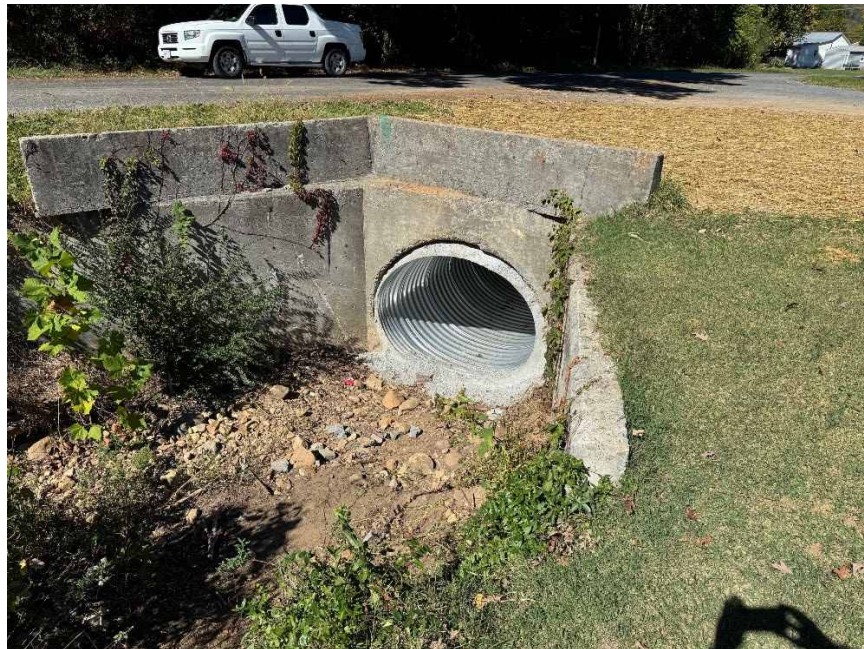
Top: Failed Entrance Prior to Temporary Repair  
Bottom: Temporary Repair (10' of replacement pipe at entrance)

The Woodland Avenue culvert on Pedlar Gap Run was installed in the 1970s and due to corrosion, has collapsed at its entrance and deformed along its 150-foot length. The City has just completed a temporary, emergency repair to its entrance, but the culvert must be replaced in the very near term to avoid total collapse. The culvert is hydraulically undersized and the 1999 NRCS report recommended replacing it with a large, single-span, precast structure, but did not give the size. Buena Vista should begin the process to analyze the flows, prepare the necessary design and construction documents, and bid the project to contractors. The analysis, design, and bid documents

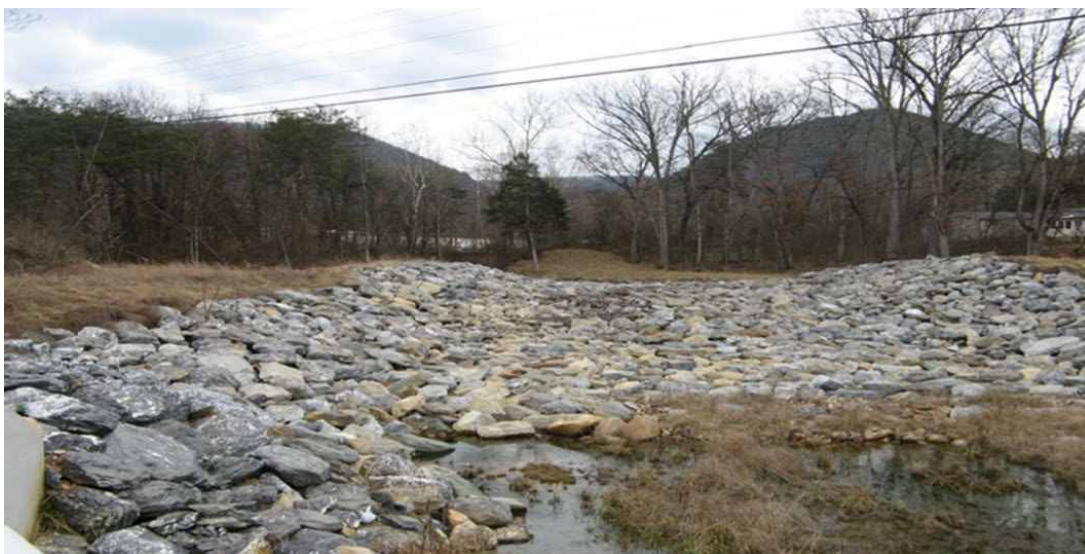
*Chalkmine Run Debris Basin Circa 2010*

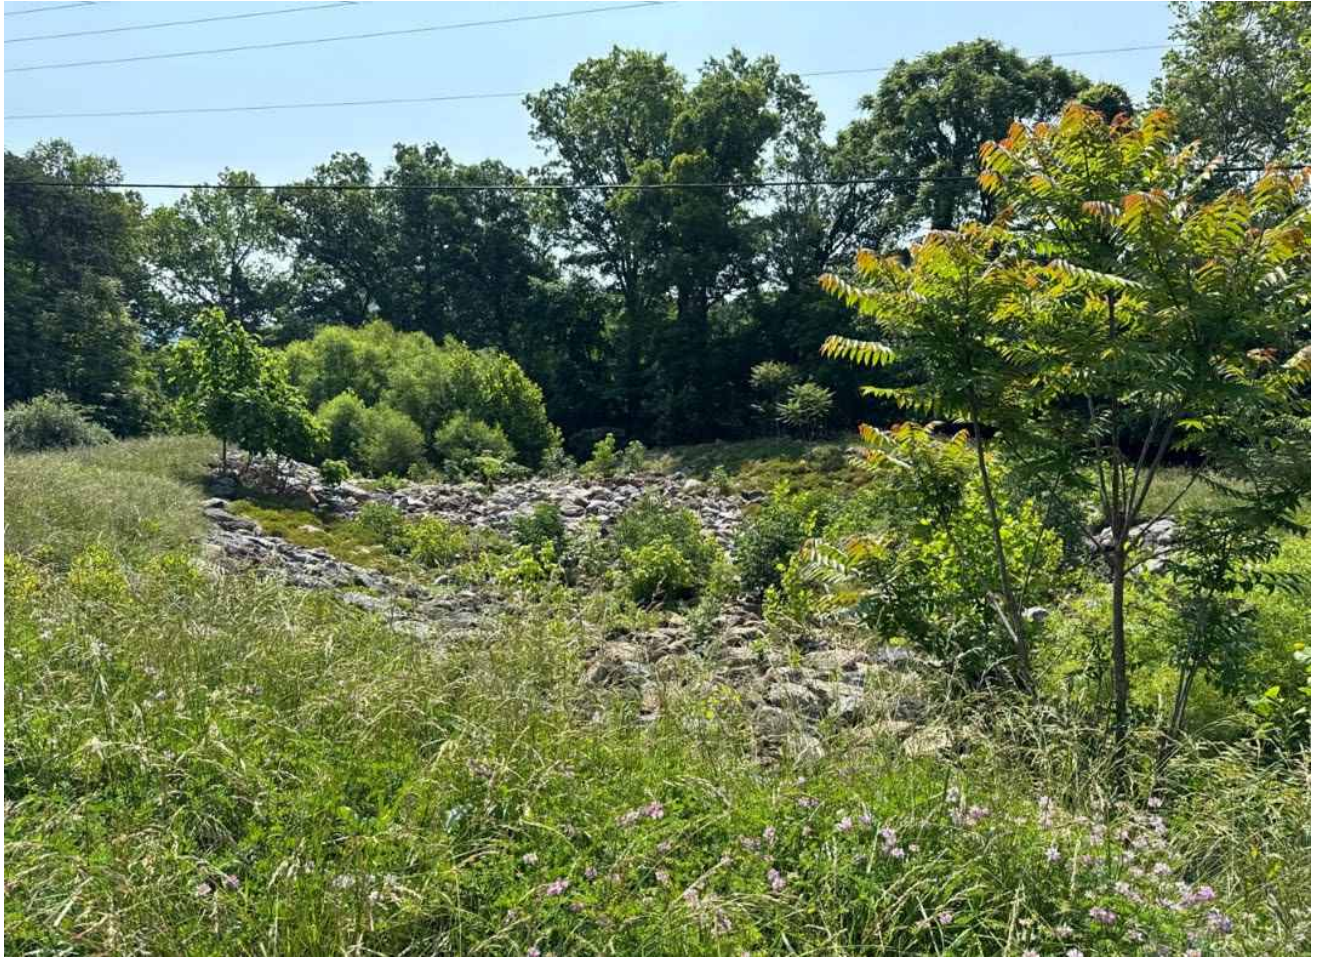
*The Same Basin in 2025*

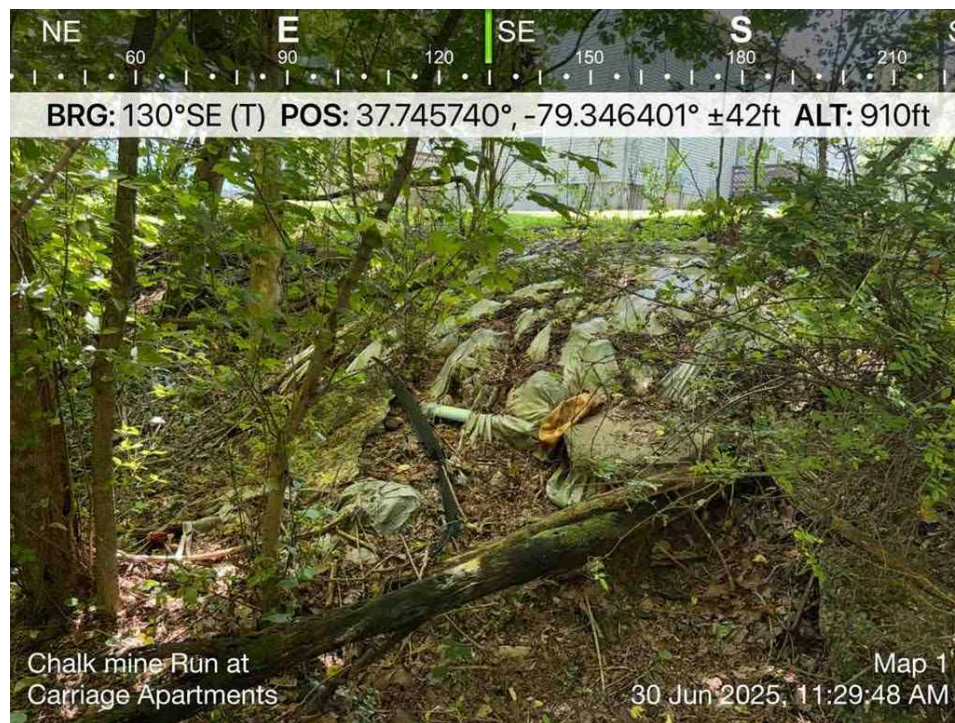
*Rip-Rap Covered by a Tarp Reinforcing the Embankment Behind Carriage House Apartments*

As of 2025, the bridges appear to be in good condition, though the adjacent channel and banks are in need of maintenance, as later discussed. It is clear that several property owners have informally worked on the channels, as shown below in a photo taken behind the Carriage House Apartments.

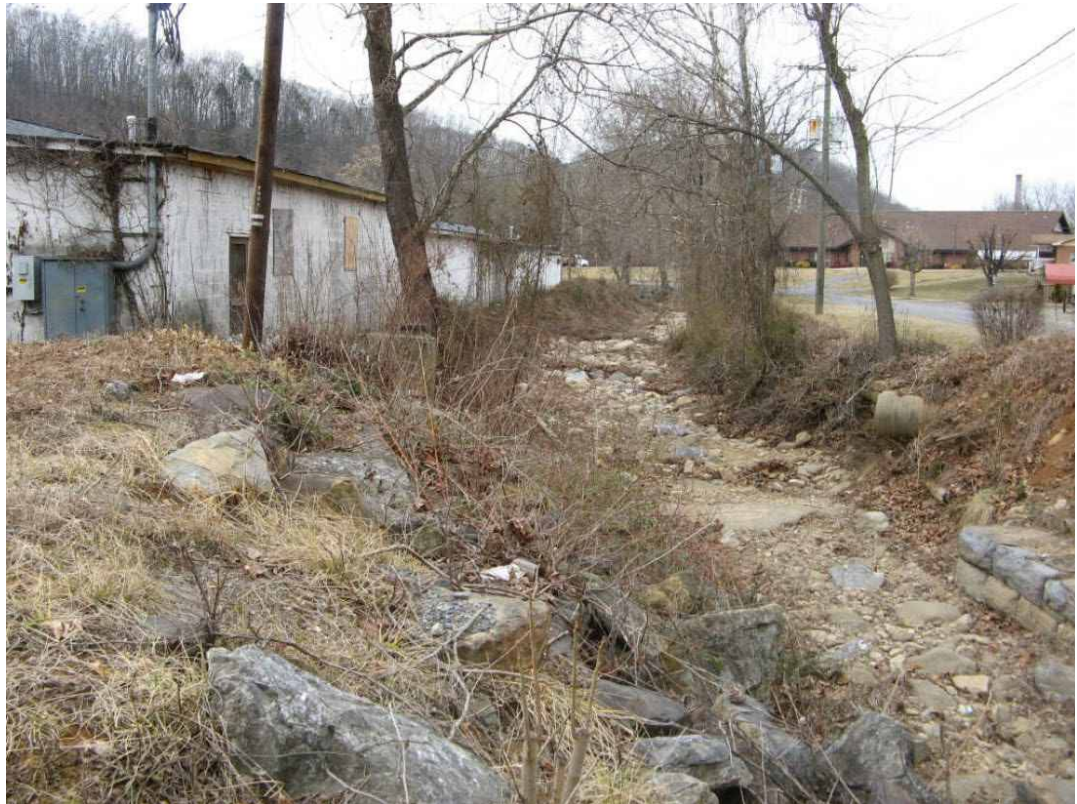
The photo below was taken in 2010 looking downstream at the motel which is just upstream of the Route 60 bridge. Since then, the channel has further deteriorated, placing the structure in even greater jeopardy. Buena Vista leadership has recently expressed a desire to evaluate options for stabilizing the channel in this area to reduce damage potential damage to the motel and nearby properties.

The upstream end of the motel is approximately 650' upstream of Route 60, which is less than half the estimated 1,495' of proposed channel improvements in the URS study. A sensible first step toward examining the situation in 2025 would be to modify the URS model to use the FEMA/FIS 100-yr flow, and remove the recommended improvements upstream of the motel, then evaluate the impacts on the surrounding floodplain. The best-case-outcome would be that the water escaping the narrower upstream channel would not flood the motel and that the shorter length of channel improvements along the motel would be sufficient to protect it. Any section of channel should be designed to withstand higher flows than FEMA's 100-yr event. There is a tremendous increase in momentum and energy between 1,920 cfs and 7,743 cfs and the sharp turn behind the motel would be subject to extreme horizontal force as the water changes direction.

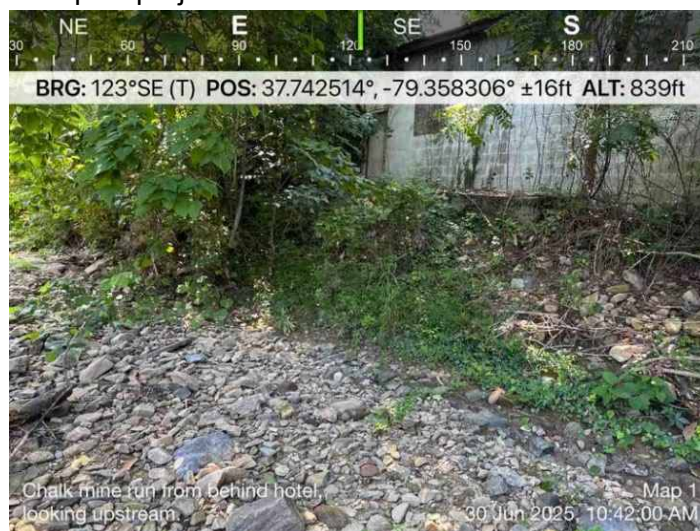
Some of the vegetation, such as large tree roots, is helping to stabilize the bank, especially on the side opposite of the motel. This should probably not be removed unless there is a plan in place to stabilize the immediate area.

2. The worst erosion and most impending damage appear to be behind the motel for approximately 300' downstream of Alleghany Avenue. Here, the channel top is sometimes within 2' to 3' horizontally of the building. If the motel structure is expected to remain indefinitely, the property owner or the City should consider at least removing the obstructive vegetation and armoring the motel embankment with large rip-rap such as Class III. This would be a capital project.

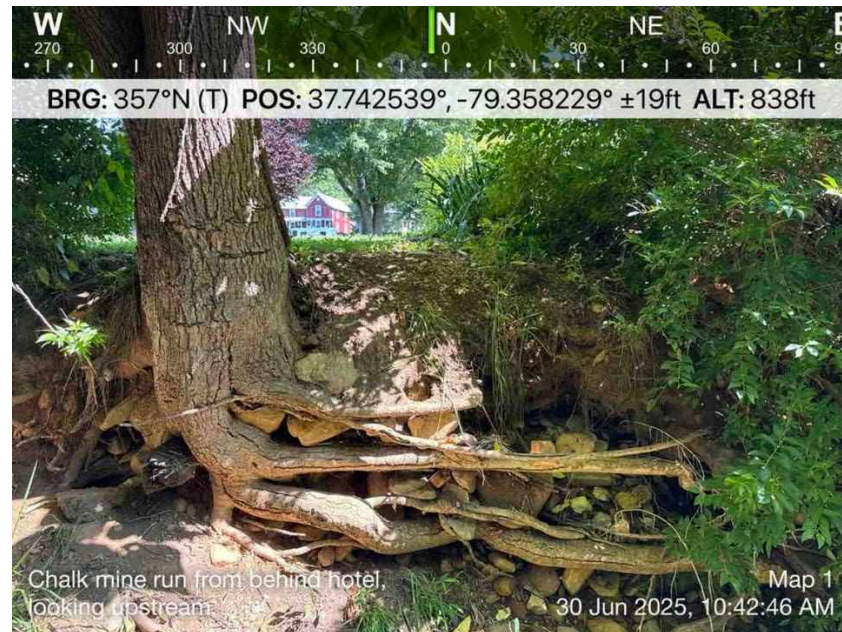
The 2010 URS plan would have increased the channel capacity in this area to contain the 5-yr to 10-yr event and would have made the channel resistant to damage from much larger storms.
