BONTEX / BUENA VISTA PAPER COMPANY

Building Complex Reuse Study

Buena Vista, VA

CONDITIONS ASSESSMENT

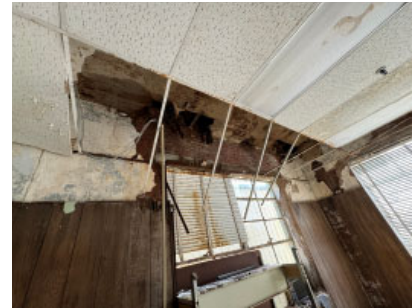
Interior deterioration of materials due to water infiltration at failed roof.

- For immediate stabilization, replace all areas of failing roofs and flashing, while addressing gutter/downspout deficiencies to prevent future water concerns.

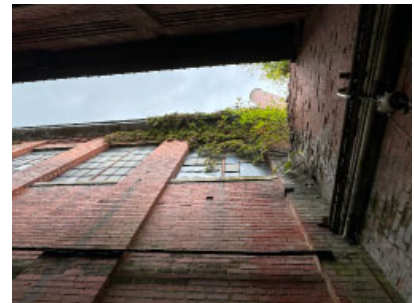
Vegetative growth and masonry deterioration at failed roof edge.

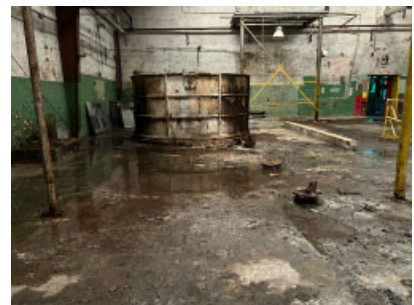
Water infiltration through roof openings.

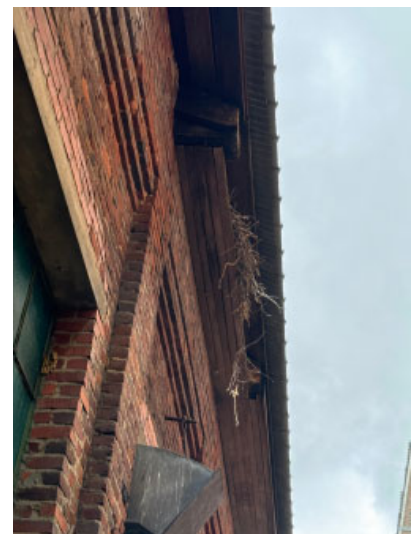
Wood soffit deterioration.

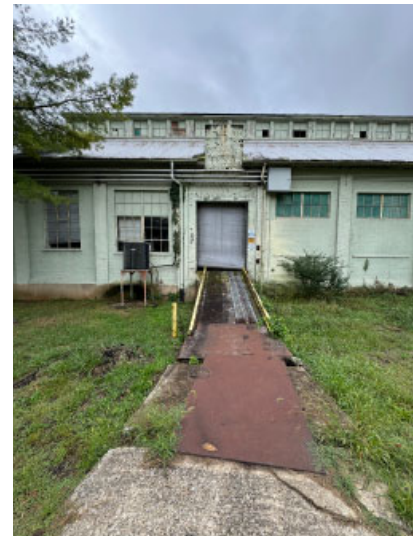
Typical mill brick pier wall construction. Section D has monitor at the roof ridge.

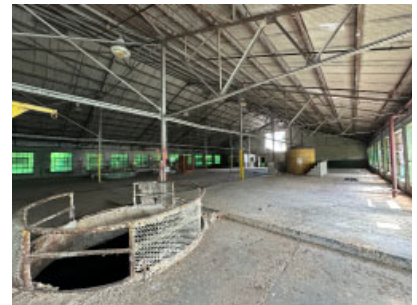
Section I, Second Floor: Roof structure.

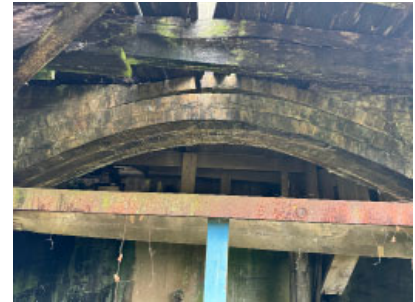
Section M was observed from the exterior. Section M is constructed of unpainted buff-color brick and is built over the Antebellum Moomaw's Lock. The lock's dressed limestone walls are used as the foundation for the building, and a large segmental arch spans over the lock under the building. The interior of the structure was not visible during the site visit. Section M appears to be a one-story structure built on existing stone walls and supported with steel framing and a brick arch. Steel beams create the structure for a walkway connecting the west side of Section M to the south door of Section N. There are several major structural deficiencies evident on the west side of Section M, namely, a major crack and separation in the brick on the north side of a CMU block infilled window, and major cracks and separations in the segmented arch under the floor level. Water infiltration and severe staining have affected the lower courses of brick, and the wood decking on the walkway connecting to Section N is heavily deteriorated. Existing guardrails are damaged and/or out of place, with sections missing altogether. The other sides of the structure were not visible during the visit.

Section M: Failed brick masonry arch.

While the evaluation of Section M was limited to the west exterior wall, the masonry is in need of attention. Major cracks and separation were observed. Masonry in Sections N/O is limited to the southern ramp wall connecting Section N with lower level of Section L. This brick masonry wall appears to be part of a previous building, and the entirety of the wall is painted. Approximately 15% of mortar joints are deteriorated, and several brick units are damaged or are defacing. Paint is peeling off the brick in these areas.

- Consider engaging a structural engineer to review the integrity of the basement structural framing, given the amount of standing water present.
- Consider engaging a structural engineer to evaluate Section M's masonry failures and develop a stabilization strategy for the structure.
- Evaluate if Section G's removed columns affect its structural integrity.
- Repair framing / surfaces of walkways to access Sections M and K.
- Analyze the loading capacity of the floor framing to verify it is adequate for the proposed new use of the building.

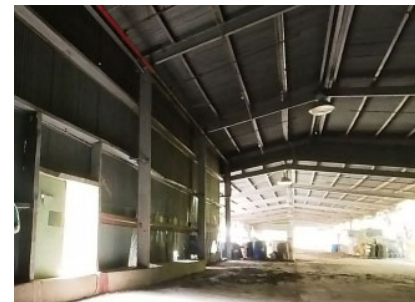
Section N: South side support beam, in bay to the right of doorway, is damaged.

- Evaluate damaged support beam on south wall of Section N.

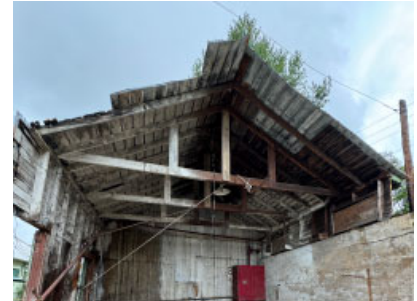
The Chip House, Building X, is a one- and two- story structure composed of wood framing with painted corrugated metal siding. Its gable roofs are metal-sheathed to match the siding. The timber framing of Building X is heavily deteriorated. Evidence of wood boring insects has reduced the dimension of framing at the base of many posts and studs.

Building X: East end deterioration.

- While there is extensive deterioration, immediate demolition is not the recommended approach. The Chip House is a contributing structure in the Bontex/Columbian Paper Company historic site as listed on the National Register of Historic Places. Demolition of a contributing structure may result in denial of certification of the rehabilitation; the historic status of the property may be compromised. Since the Chip House was constructed during the period of significance, original materials are still presented and unaltered, and possesses historic significance on site, the following is the recommended approach:

- Recommend engaging a structural engineer to further evaluate the structure of the Chip House. Contact and review with the Virginia State Historic Preservation Office.

- Stabilization is the preferred solution, as the Chip House is a contributing structure in the Bontex/Columbian Paper Company historic site as listed on the National Register of Historic Places.

- If demolition does occur, the building will need to be fully documented, including measurements, photographs, before demolition activities start.

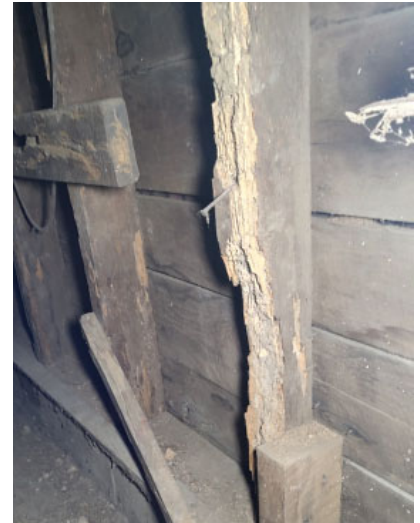
Building X: Termite damage at wood studs.

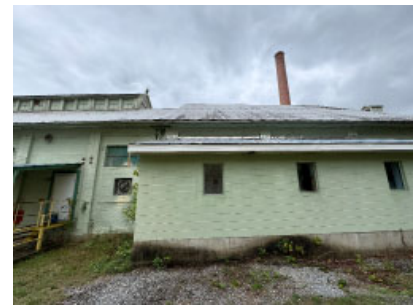
Section D has a combination of a gable roof with monitor window and shed roof. There is a hole in the roof of Section D on the south wall of the mill area, allowing water infiltration. There is a similar degree of water infiltration in the southeast corner of the office area. These failures have caused extensive deterioration of finishes and structure.

Section D: Typical roof condition observed on site.

- Repair failed roof areas throughout; replace decking and roofing in locations where water leaks are actively deteriorating the structure, namely in Section D.
- Ensure gutters are cleared of debris and vegetation.
- Evaluate the flashing and condition of the southwest corner of the Section C roof.
- Based on proposed use in each building section, install an insulated roofing system with appropriate drainage system, and in keeping with Secretary of the Interior Standards for Rehabilitation, if pursuing Historic Tax Credits.

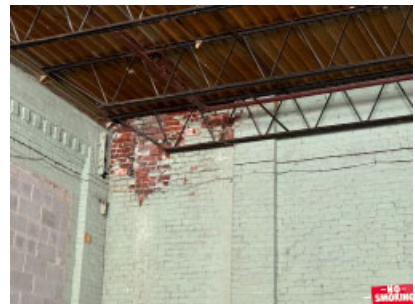
At the shed roof of Section C, there is evidence of water infiltration in the southwest corner of the roof, where the roof of Section C connects to Section E/F.

Section C: Southwest corner roof condition.

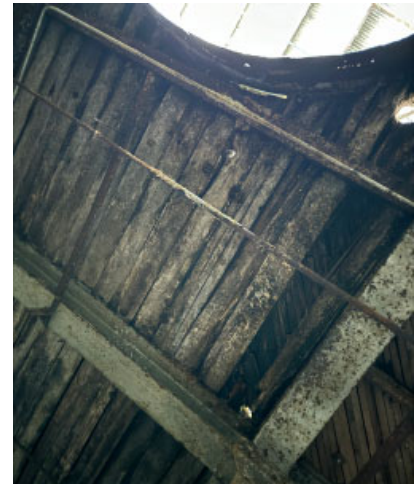
Section I: Underside of second floor structure.

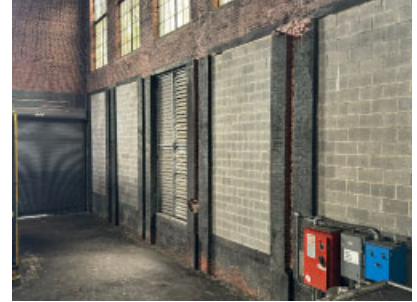
Section G: CMU block infill at original window openings.

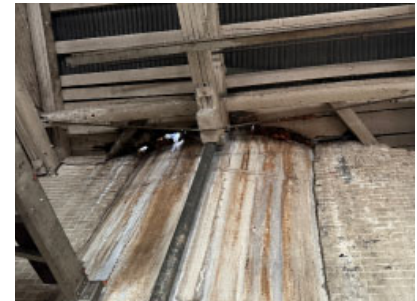
Section B has a mix of half round and non-historic K-style gutters leading to downspouts. There is water infiltration and roof failures where tanks are integrated through the roof and wall.

Section B: Tank integrated into wall structure in Room 2.

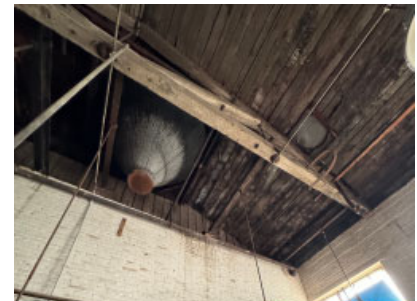
Section B: Room 4 through-roof tank.

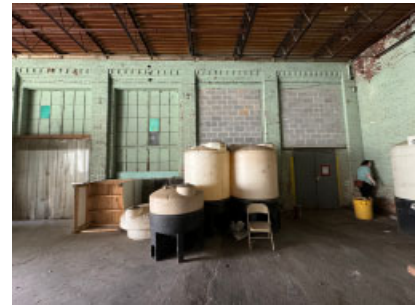
Section C: South wall, which is the exterior of Section B.

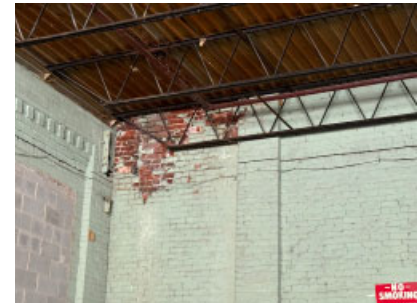
Section C: Southwest corner masonry condition.

Given the utilitarian nature of this loading dock area at Section C, the extent of interior finishes is limited. The brick masonry walls to the north, west, and south are painted. Some areas have paint deterioration due to physical wear and contact and/or water infiltration. The floor is bare concrete.

- Abate hazardous materials per recommendations in the separate Phase I ESA and Hazardous Materials Survey Report.
- Scrape and clean peeling paint on brick masonry surfaces with the gentlest means possible. If repainting is desired, use a breathable, low-VOC paint product.
- Provide new finishes as required by the proposed use
- Remove or remount loose corrugated metal panels at wall enclosures.

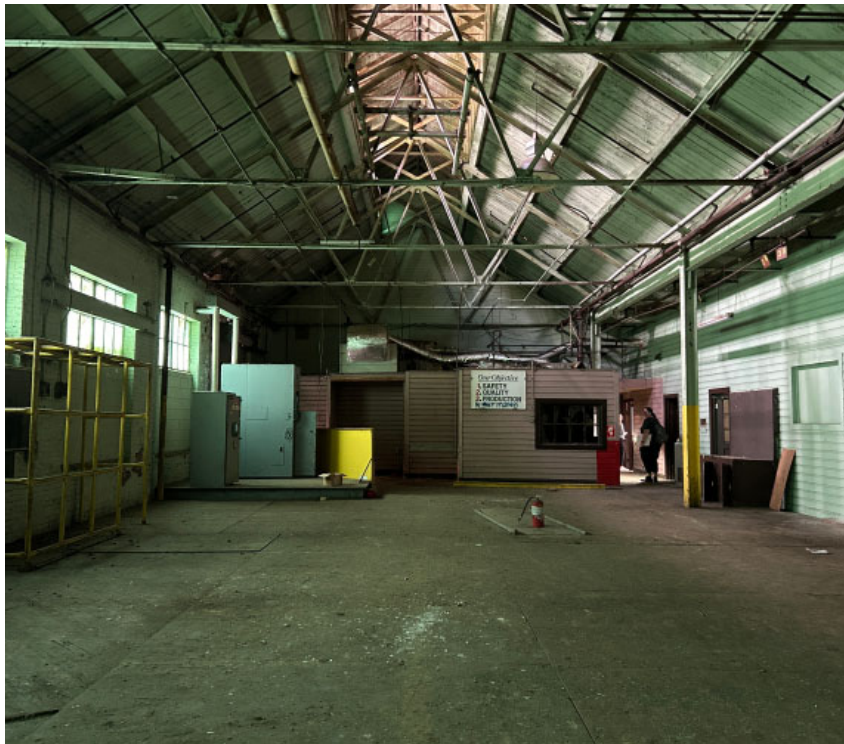
Section D: Looking east towards offices.

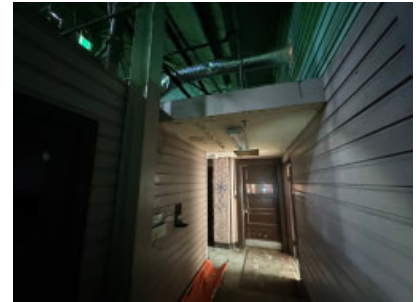
The office areas in Section E/F and D contain original paneled wood doors with lites. These historic doors are in place and should be preserved. Some elements of the doors have been modified or damaged, including missing/broken lites, or modified door hardware.

Section D: Office space hallway with original wood siding and doors.

- Repair or replace non-historic overhead doors, exterior doors, and hardware as needed to ensure appropriate operation.
- Repair historic doors and hardware to functional condition. Replace damaged or missing glass with glass to match the original.
- Remove non-functioning window air conditioning units and replace glass where missing to match original. Repair window, hardware, and glazing in a manner consistent with the Secretary of the Interior's Standards for Rehabilitation.

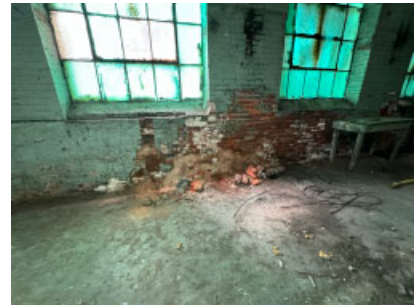
Section E/F: South wall masonry deterioration.

- Generally, repoint all failed mortar joints in the brick, repair cracked or damaged brick units, and replace units that have been displaced with salvaged brick or units to match in color, dimension, and bond pattern.
- Remove vegetation from the exterior faces of the building.
- Remove flaking paint with the gentlest means possible.

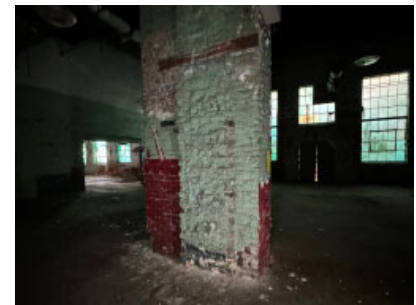
Section E/F: West half brick pier.

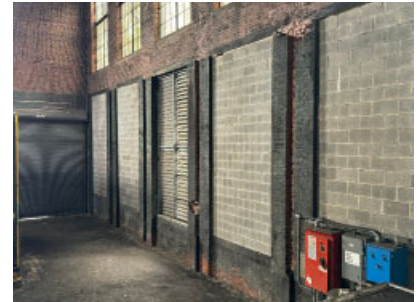
Section G: CMU infilled window openings.

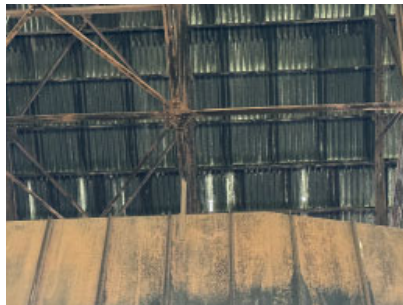
Section G: Typical roof condition, with exposed trusses and corrugated metal roof panels.

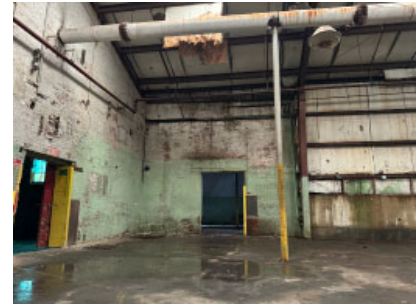
Section I: Southeast corner. The south wall is brick, then transitions to a concrete foundation wall with metal paneling above.

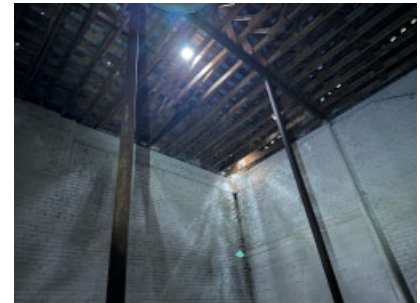
Section I: South room wood roof framing and hole.

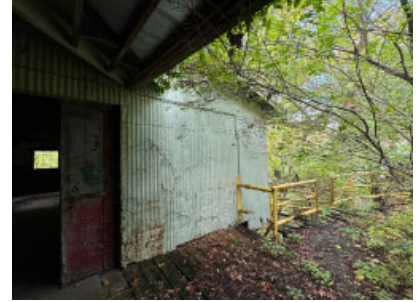
Section K: Northwest corner and wood catwalk.

Section K has a sliding door on the north side, and a swing door at the southern end of the west wall, both connected by a catwalk constructed of metal framing and wood decking. The catwalk is severely deteriorated and its condition prevented access to Section K.

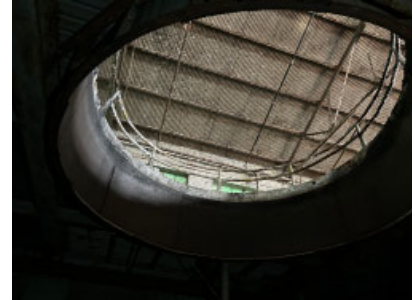
Section L: Round floor opening, looking toward roof from first floor.

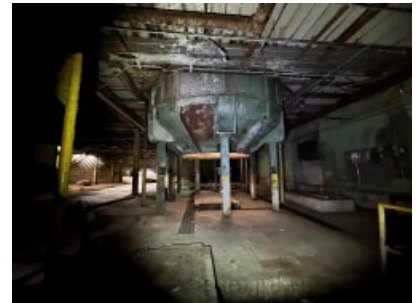
Section L: Existing tank on first floor, which extends into the second floor.

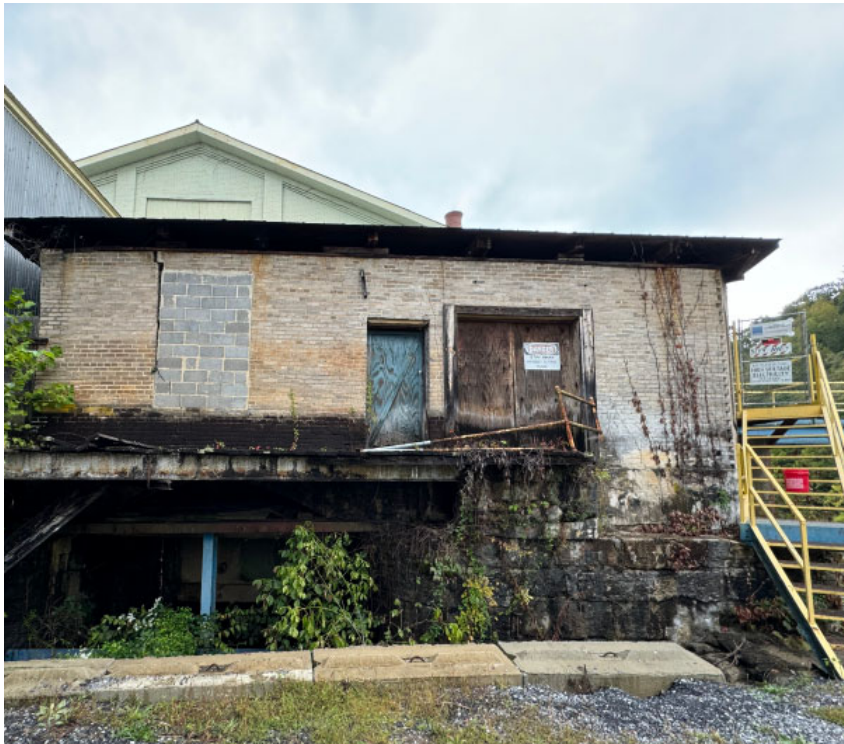
Section M: West wall.

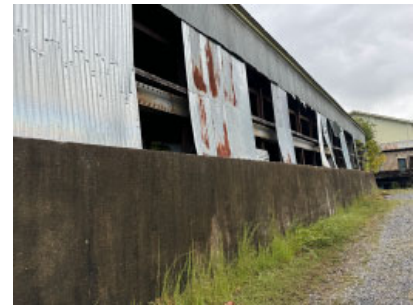
Section N: Typical exterior wall condition, continues along Section O.

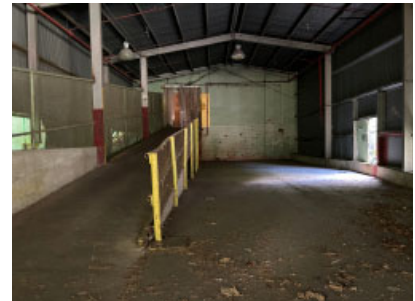
Section N: Ramp to Section L.

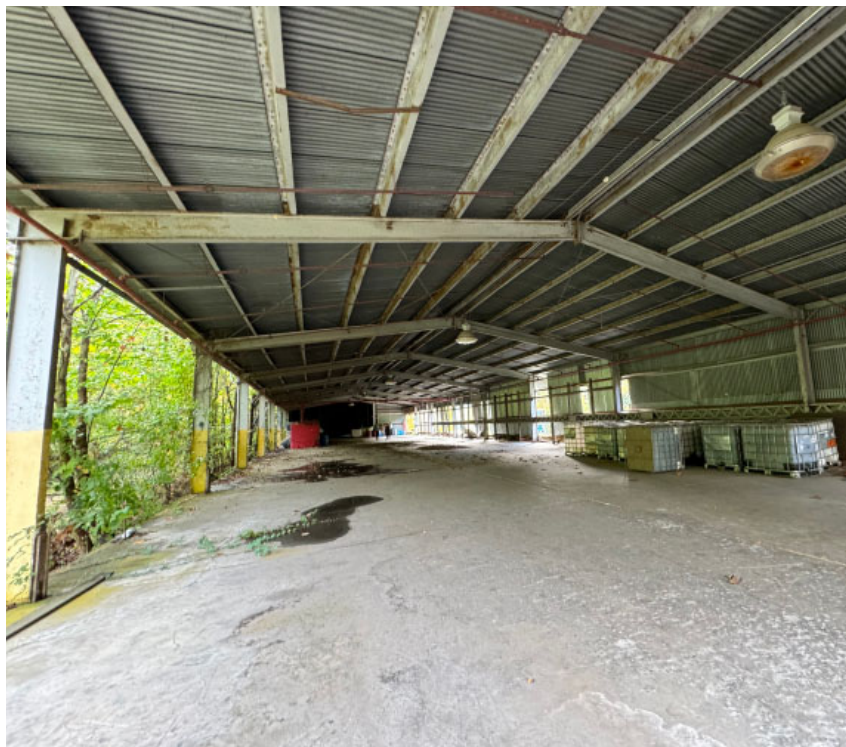
Section O: Looking east, with Section N at the far end of the structure.

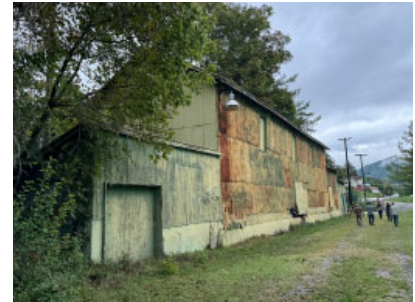
Building X: View of south wall.

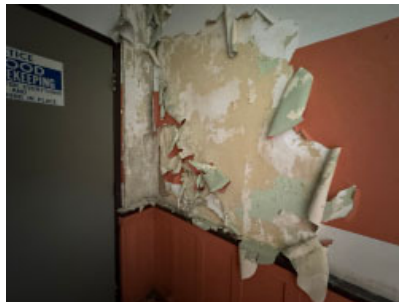
Mold and dampness was observed in the Section H laboratory, with deterioration of finishes. In the southeast corner of Section D there is extensive water damage to finishes due to a failure in the roof/ exterior wall.

Section D: Office wall finish deterioration.

- Abate hazardous materials per recommendations in the separate Phase I ESA and Hazardous Materials Survey Report.
- Scrape and clean peeling paint on brick masonry surfaces with the gentlest means possible. If repainting is desired, use a breathable, low-VOC paint product.
- Provide new finishes as required by the proposed use
- Remove or remount loose corrugated metal panels at wall enclosures.

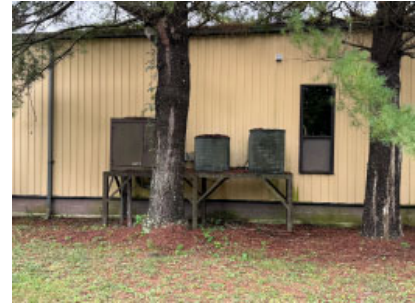
Most office spaces and locker rooms have window-mounted air conditioning units and electric baseboard heaters. Where observed, these systems were noted to be in poor condition. Some work areas in the mill building had wall- or ceiling-suspended gas heaters. Like the other equipment, these units are past their useful life. The main level office area of Section D has central air conditioning system with ducts routed above the ceilings.

Section A: Air conditioning units, north side of structure.

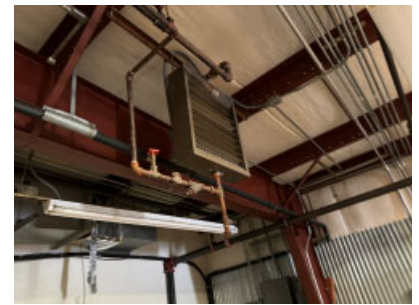
Section A: Gas heater.

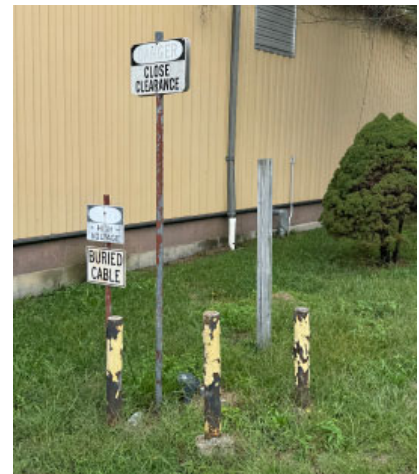
Section A, north side: Buried cable signs opposite the former transformer yard.
