BONTEX / BUENA VISTA PAPER COMPANY

Building Complex Reuse Study

Buena Vista, VA

CONDITIONS ASSESSMENT

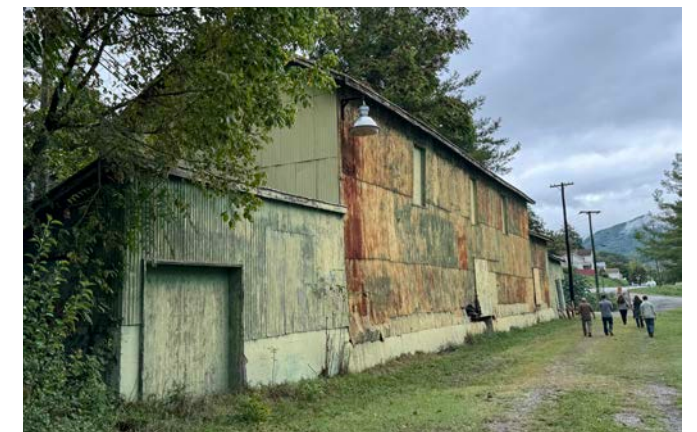
The Chip House is a contributing structure to the north of the main mill building, and its structural integrity requires further evaluation. From a historic standpoint, stabilization is the priority, and is the recommendation for this study. The second goal would be to stabilize and rehabilitate. Demolition is not recommended, as it would remove historic material and a historic structure that could be stabilized by a future entity. Treatment of the chip house, as well as the rest of the site, should be reviewed with the Virginia State Historic Preservation Office.

The Chip House.

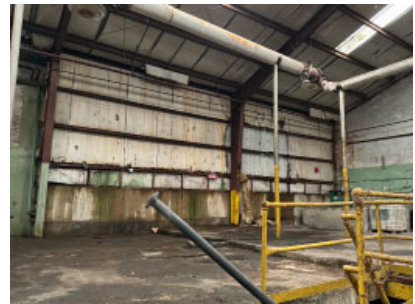
Section I: South wall.

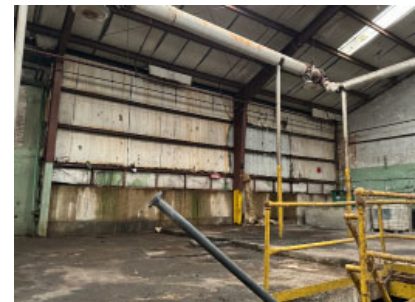
Section I is a hybrid structure. Its north, east, west, and partial south walls are brick masonry. A gabled rigid frame spans north to south and is built to the interior face of the existing brick walls. Intermediate steel beams span east to west. Where the brick masonry wall ends on the south wall, a concrete foundation wall continues, with and steel purlins spanning between the rigid frame columns. The basement is accessed via a concrete stair. There is a smaller room accessed through an opening in the brick wall to the south, which has a wood framed gable roof. A door on the east side of this room accesses an exterior catwalk which connects to Section G. Extensive water infiltration was observed throughout, due to failures in the roof and along the steel framed south wall, but the steel structure appears to be in good condition.

Section I: Steel structure adjacent to brick masonry.

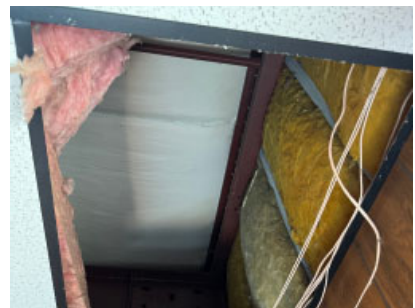
Section A: Typical roof insulation.

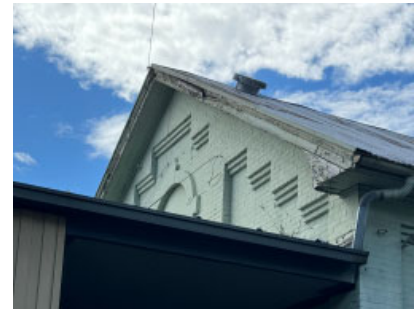
Section D: East end brick detailing.

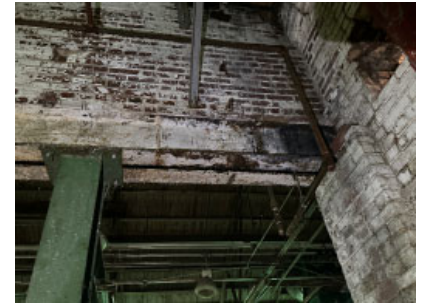
Section J: Lintel and structure at connection to Section H.

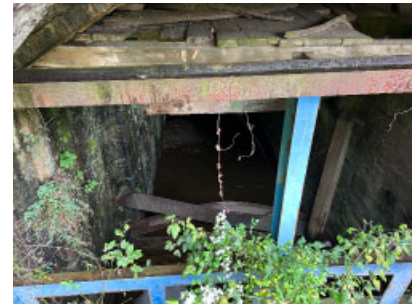
Section M: View of head race from river.

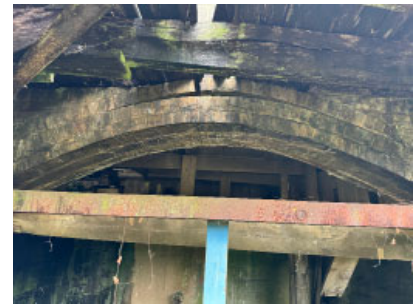
Section M: Arch and partial view to interior.

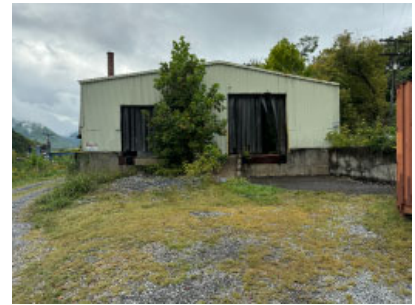
Section O: West end loading area and ramp.

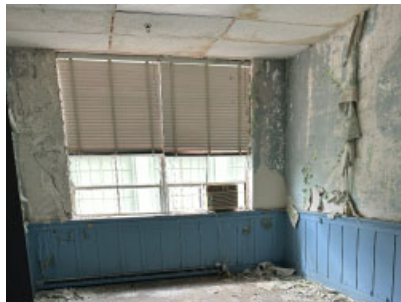
Section D: Office.

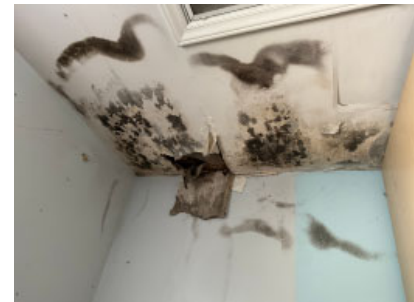
Section D Laboratory: Black mold.

- Abate hazardous materials per recommendations in the separate Phase I ESA and Hazardous Materials Survey Report.
- Scrape and clean peeling paint on brick masonry surfaces with the gentlest means possible. If repainting is desired, use a breathable, low-VOC paint product.
- Provide new finishes as required by the proposed use
- Remove or remount loose corrugated metal panels at wall enclosures.

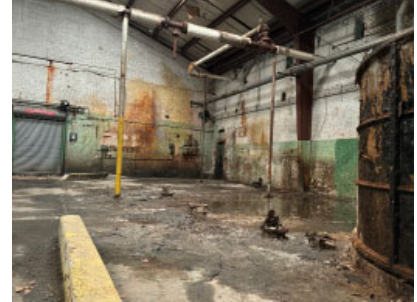
Section I: Interior conditions.

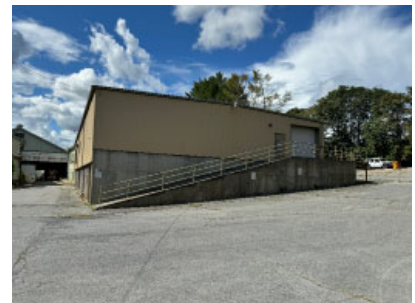
Section A: East entry.

- Depending on the proposed use, provide accessible entries and routes to all primary spaces.
- Evaluate accessibility holistically, with regard to site entry points, accessible routes through connected spaces, and the provision of and access to restrooms with code-required accessible fixtures.
- Modify existing door hardware on historic doors to remain if needed to provide
